SERVICE BULLETIN FOR ON/OFF OXYGEN VALVES

05/25/2006

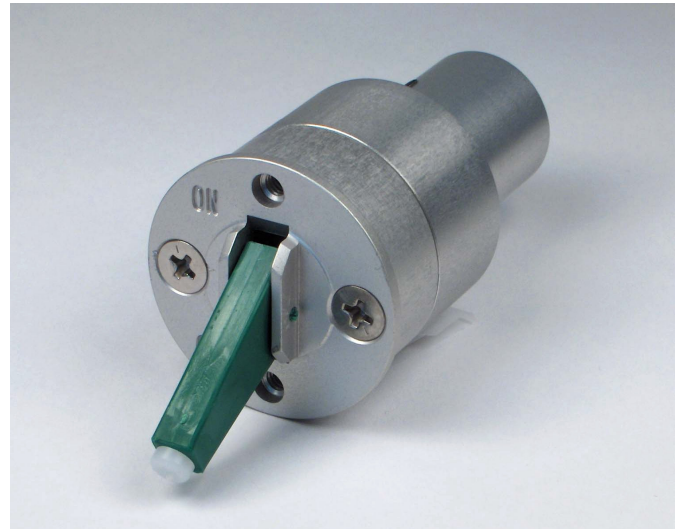
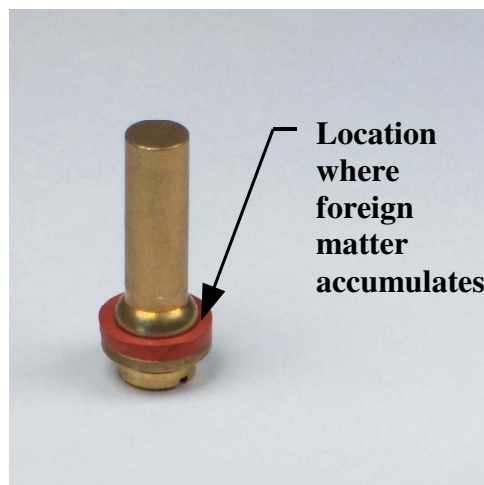
The use of these valves with contaminated oxygen lines is the normal reason for the leaks in question. Oxygen lines that have not been cleaned for use with oxygen may contain particulates that are carried by the oxygen and deposited on the valve seat of the toggle. These particulates prevent the toggle from sealing properly and are the cause of the leak.

Although these particulates may dislodge and the toggle seal may be re-established, an overhaul of the toggle is recommended to ensure no other debris has entered the toggle. This overhaul is at the discretion of the customer and is not covered by warranty.

CAUTION: When handling oxygen system components and assemblies, it is imperative that the interior be kept free of any particulates.
